### **Case Report**

# A Fatal Perforating Lawn Mower Injury

Ramsey County Medical Examiner's Office

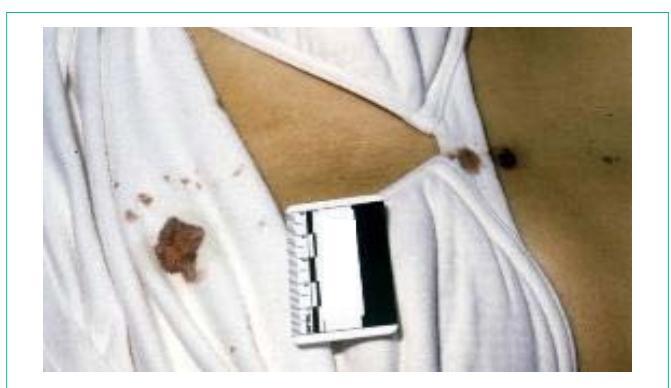
A 48 year old female was found lying in a prone position unresponsive on the ground outside her residence by her husband. Emergency personnel responded but did not provide any significant resuscitation as livor mortis and rigor mortis were already present. The decedent was fully dressed with one shoe on and the other shoe located approximately 10 feet away. An initial examination of the body revealed a small penetrating injury to the mid chest with a perforation of the overlying bra and shirt (Figure 1, 2). Only a small amount of blood was present on the clothing.

Figure 2: The decedent at the time of the autopsy with a perforating injury to the upper abdomen/lower chest just below the level of the bra which is slightly raised. A corresponding spot of dried blood is noted on the bra and raised shirt.

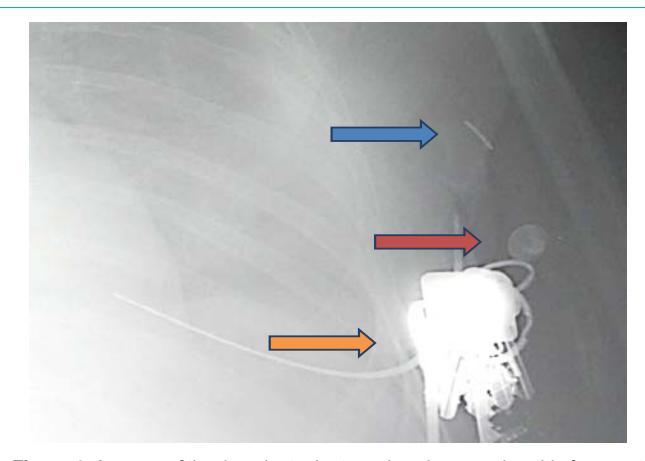
Figure 4: An x-ray of the decedent prior to undressing reveals a thin fragment of projectile wire (blue arrow), an EKG pad snap (orange arrow) and a set of keys located in the decedent's jacket pocket (green arrow) overlying the underwire of the decedent's bra.

A postmortem x-ray was obtained while the decedent was still clothed and revealed multiple opaque objects including keys, bra underwire, EKG pads and a small linear radiopaque fragment of wire (Figure 4). This small linear metal object, consistent with a fragment of wire, was located within the material of the left bra cup (Figure 5). Adjacent to the piece of wire was a small exit wound on the skin along the left lateral upper chest.

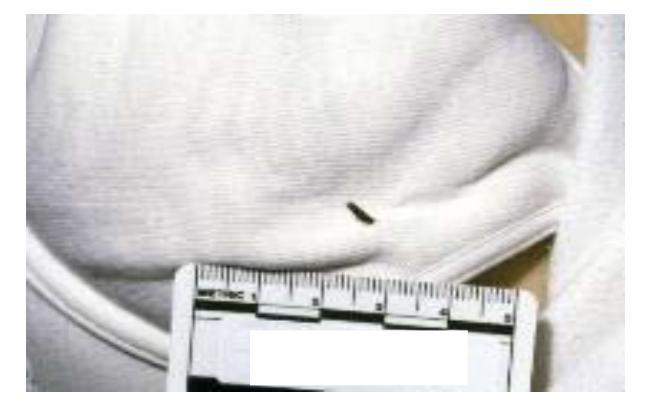
Figure 5: A small fragment of wire was located in the material of the left bra cup.

The wire fragment was compared to the portion of wire located adjacent to the lawn mower and was consistent in diameter and color.

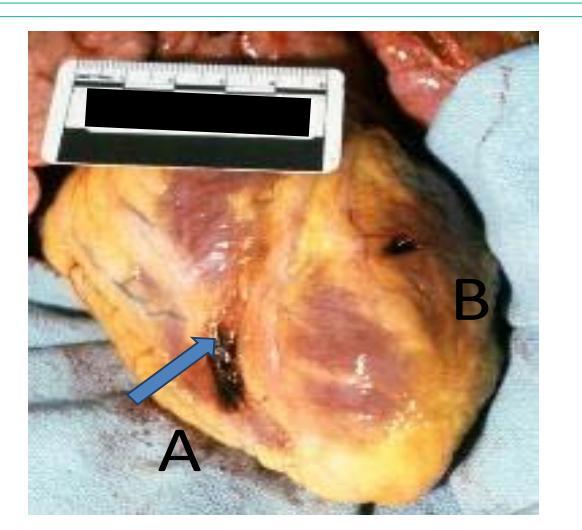
**Figure 6:** The heart is shown with "A" representing the entrance wound and "B" marking the exit wound of the wire projectile. The arrow indicates the direction of the wound path through the heart.

Internal examination revealed a perforation of the upper abdomen just 1.5 cm inferior to the manubrium of the sternum. The wound tract continued perforating the right ventricle of the heart, the septum and exiting the heart through the left ventricle (Figure 6). The wound continued perforating the left lung tissue and exited the left lateral chest wall. There was approximately 300 cc of liquid blood present within the pericardial space and 100 cc of blood present in the left pleural space.

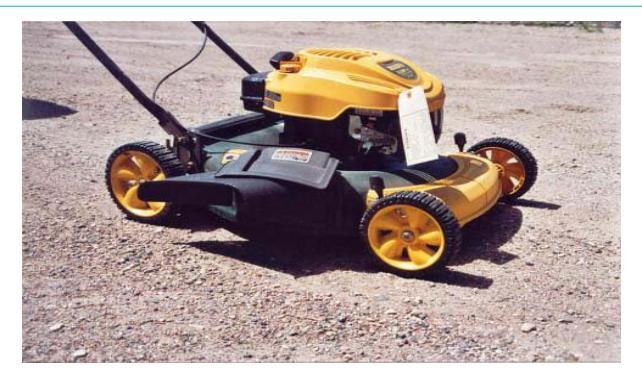
The lawn mower, a Yard Man<sup>®</sup> Model 430 Push Mower, (Figures 7, 8) was inspected and appeared to be in good working condition with no gaps around the discharge door or rear trail shield. The

Figure 7: Examination of the lawn mower revealed the mower to be in good working condition with no safety modifications noted. The mulcher door was up with an attached discharge guard which appeared securely in place.

mulcher door was up with an attached discharge guard which was securely in place. There were no modifications made to the safety equipment. Several nicks were noted to the blade, some of which appeared to be recent with exposed shiny metal.

From the autopsy, the scene investigation and examination of the lawn mower, it is proposed that the slope of the ground and possibly lifting the back end of the mower resulted in a portion of the chain link wire to be discharged under the mower trail guard to perforate the decedent. The projectile wire may have been stopped by the bone of the manubrium or sternum had the injury occurred 1.5 cm superior on the body. Despite advances in safety equipment, lawn mowers can still result in fatal injuries to operators.

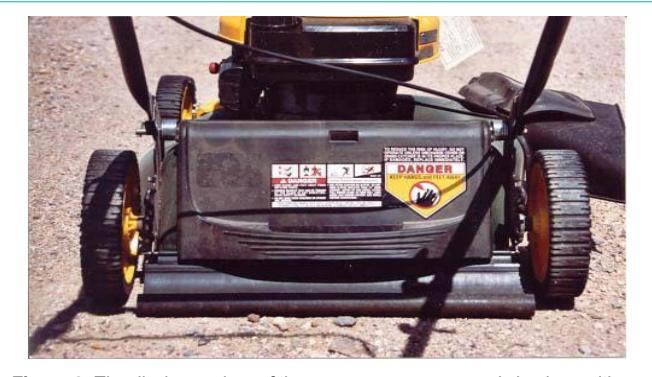
Figure 8: The discharge door of the mower appears securely in place with no gaps or defects and the trail guard is in good condition.
