Case Report

Artificial Hip Replacement Combined with Proximal Femoral Locking Plate in The Treatment of Intertrochanteric Femur Fracture with Peritrochanteric Fracture

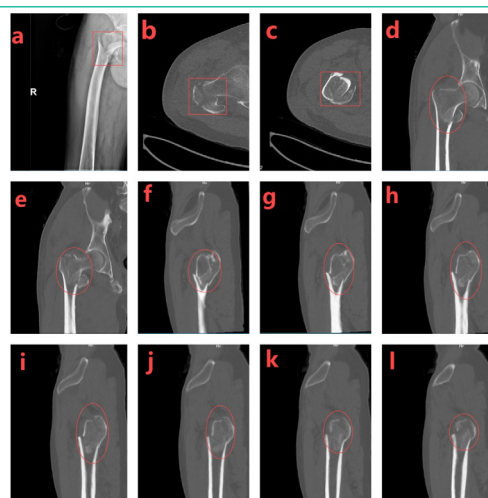
Figure 1: X-ray examination and CT scan showed a comminuted intertrochanteric fracture of the right femur, a fracture of the greater as well as the lesser trochanter of the femur, and swelling of the surrounding soft tissues.

ers. Physical examination showed that the right hip was swollen with obvious tenderness, the right lower limb showed flexion, shortening and external rotation deformity, the sensation of the right lower limb was normal, and the dorsalis pedis artery of the right side had good pulsation. X-ray examination and CT scan showed that there were comminuted fracture of the right intertrochanteric femur, fracture of the greater as well as the lesser trochanter of femur, and the surrounding soft tissues were swollen (Figure 1 a-l).

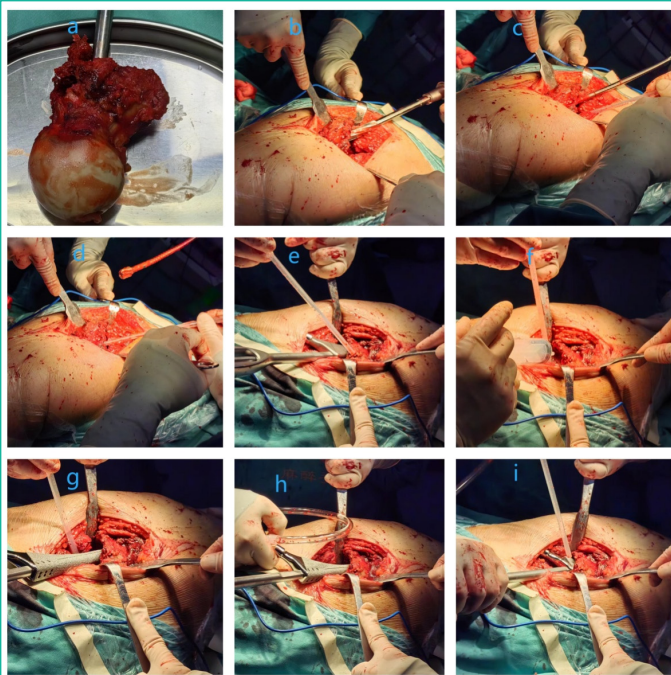
Figure 2: First, the bone marrow cavity was further expanded with a femoral stem test mould, and then the bone marrow cavity was repeatedly flushed with saline to prevent infection. Finally, a suitable femoral stalk was selected according to the size of the femoral marrow cavity and slowly implanted.

formed under general anesthesia. Intraoperative fractures of the right intertrochanteric femur, right greater and lesser trochanter were seen. The fractured femoral head and the surrounding blood clot were removed and the marrow cavity was expanded to the appropriate size. The marrow cavity was further dilated using a femoral stem test mould, and then the marrow cavity was repeatedly flushed with saline to prevent infection. Finally, the appropriate femoral stem was selected according to the size of the femoral marrow cavity, and the femoral stem was slowly implanted (Figure 2 a-i). To further stabilise the fracture, the already fractured greater trochanter was next fixed with a proximal femoral locking plate. After repositioning the fracture breaks, the fracture breaks were fixed with Kirschner's pins and pliers, then the appropriate locking plate was selected for fixation, and finally the screws were implanted, and the fracture was examined and found to be in good alignment (Figure 3 a-d). Three days after the operation, the patient could gradually walk on the ground. Postoperative X-ray examination showed that the internal fixation device was in good position (Figure 4 A-C). Continue to follow up the patient's recovery.

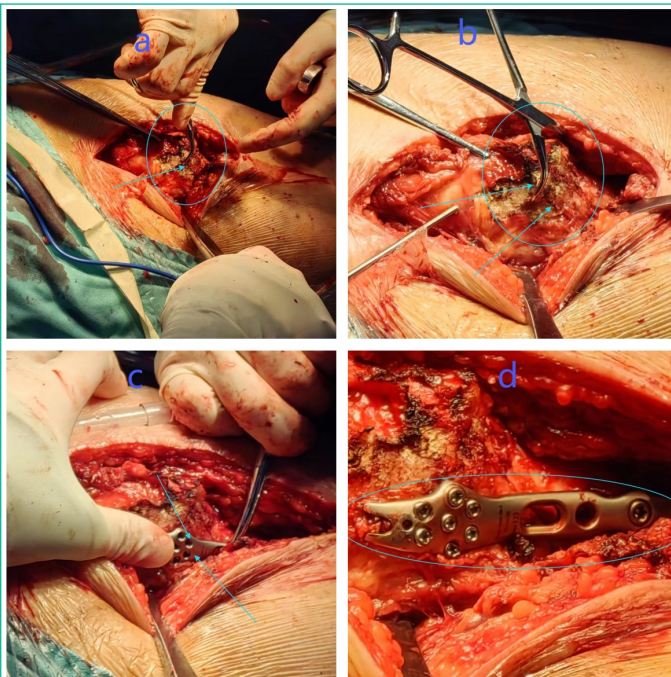
Figure 3: After fixing the already fractured greater trochanter with a locking plate of the proximal femur, the fractured broken end was reset. The fractured broken end was fixed with Kirschner's pin and pliers first, then the appropriate locking plate was selected for fixation, and finally screws were implanted.

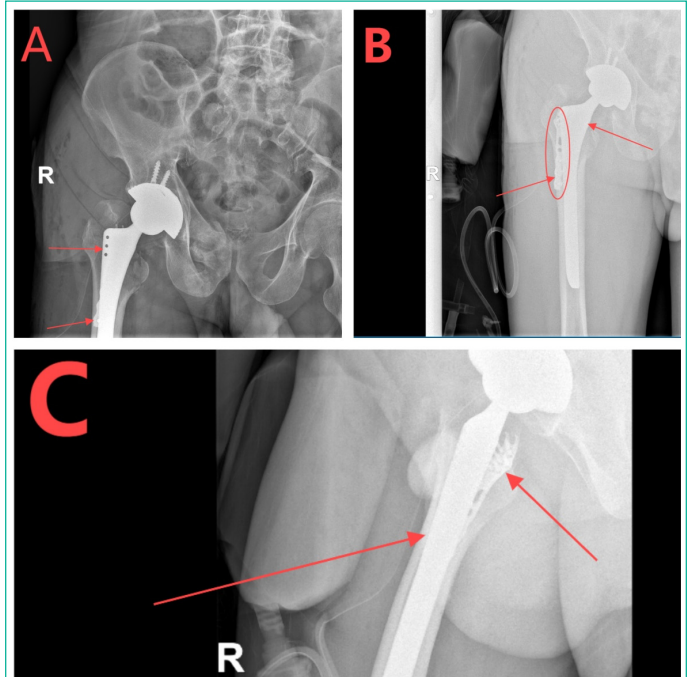
Figure 4: Internal fixation device well positioned.
