## Case Report

# Major Complications of Implants Retaining Removable Prostheses - Case Reports and Proposal of a Novel Attachment Concept

Schulz A<sup>1</sup>, Roth D<sup>2</sup>, Orujov K<sup>1</sup>, Karl M<sup>3\*</sup>,  
Grobecker-Karl T<sup>1</sup>

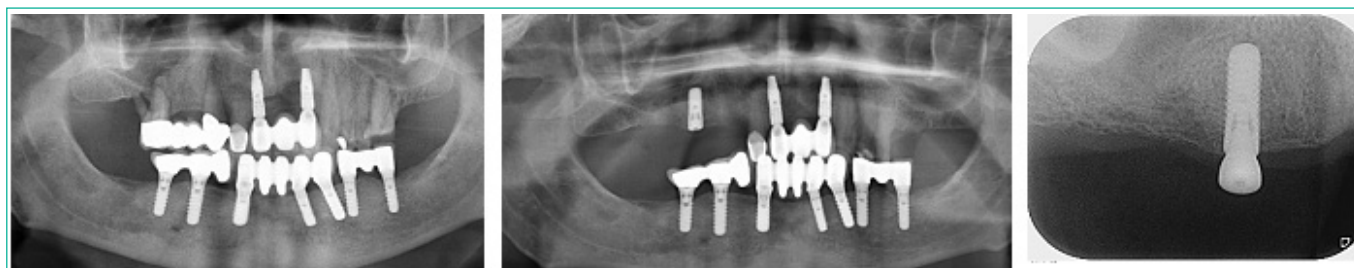
**Figure 1:** Panoramic radiograph showing implant supported restorations in the mandible while both, teeth and implants were present in the maxilla supporting fixed restorations. Abscesses had developed involving posterior teeth on both sides (a). Radiograph following implant placement in the region of the maxillary right second premolar (b). Following osseointegration, the implant was uncovered and a healing cap was installed (c).

A male patient initially presented in September 2020 at the age of 76 with implant-supported fixed restorations in the mandible (Figure 1a). Fixed restorations on implants and teeth were present in the maxilla and the patient required extractions of posterior teeth due to

abscesses. Following healing, the patient was treatment planned for a combined tooth-implant supported removable restoration in January 2021 following implant placement in the position of tooth 15 (Figures 1b, 1c). In November 2021 a prosthesis employing telescopic crowns supported by both natural abutments and implants was delivered (Figure 2).

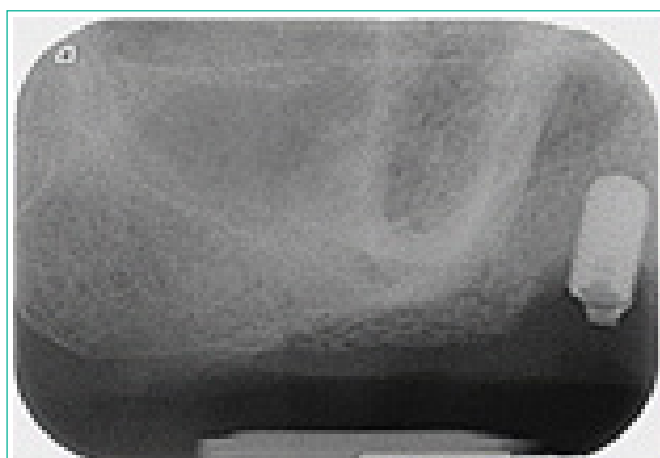
**Figure 5:** Periapical radiograph of implant in position 15 following fracture of the coronal part. A saucer-shaped bone defect is clearly visible surrounding the implant.

In September 2022 the patient presented with a fracture of the prosthesis framework (Figure 3) requiring major repair followed by a chipping fracture of an anterior facing which occurred in November 2022 (Figure 4). Ultimately, in March 2023 the implant in position 15 fractured (Figures 5, 6) with the patient reporting to our clinic as he had been unable to properly position the prosthesis for several days. As the patient was still satisfied with the function and retention of the removable restoration, it was decided not to remove the implant but to smooth it and to extend the base of the prosthesis in this area.

with the fractured implant may also be attributed to an overload situation and has similarly been observed in a well documented clinical study [29].

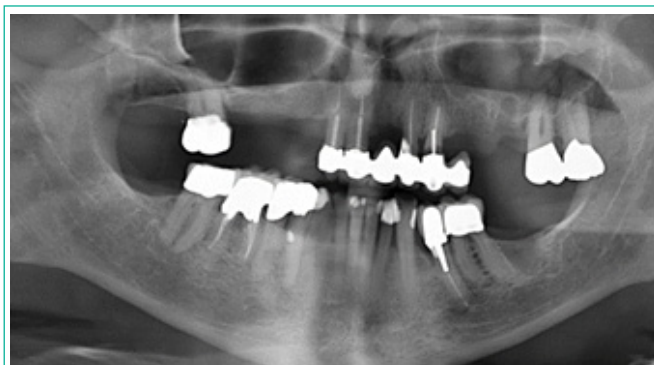
**Figure 7:** Initial patient presentation with partial edentulism and preexisting fixed restorations in both jaws

been restored elsewhere with conventional tooth-supported fixed restorations and showing a mix of periodontal and endodontic problems (Figure 7). Following implant placement in positions 13 and 25 in June 2012, a removable, horseshoe-shaped maxillary prosthesis on telescopic crowns was delivered in February 2013 (Figure 8). As part of the maintenance program, the patient was seen on a regular basis only requiring minor interventions such as cementing loose primary telescopic crowns.

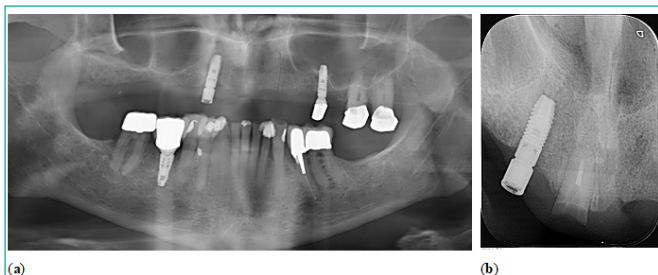
**Figure 10:** Two years after prosthesis conversion, tooth 11 fractured and had to be extracted (a). The preoperatively taken periapical radiograph revealed an osteolysis surrounding implant 13 which was also clinically mobile (b).

and ultimately replaced by a locator abutment in September 2021. The female attachment part was then retrofitted into the prosthesis (Figure 8c). In September 2023, tooth 11 fractured and had to be extracted (Figure 10a) with the preoperative radiograph revealing an osteolysis around implant 13 correlating with its clinical mobility (Figure 10b). The implant was ultimately removed (Figure 11) and the prosthesis modified such way that the palate was completely covered for additional support.

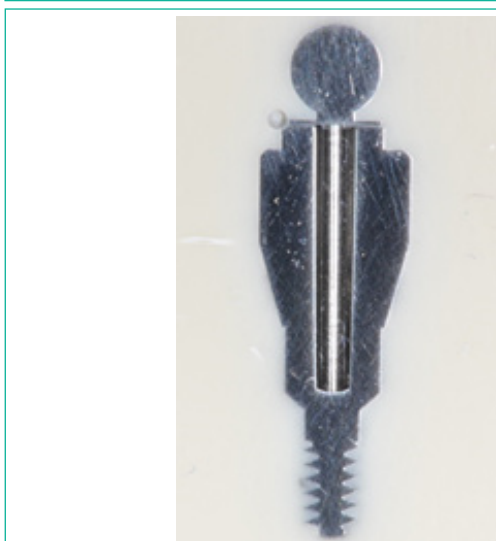
**Figure 13:** Cross-sectional view of a prototype flexible attachment system (Reflex, Hader Solutions & Distribution) with a ball mounted on a centrally positioned beam allowing for lateral movement while maintaining vertical dimensions.

flexible attachment (Reflex, Hader Solutions & Distribution) both of which could be mounted on the implants (Figure 13) [30,31].

Ideally, such an attachment system would also act as stress breaker preventing implant overload even in cantilever situations as seen in the clinical cases. As evidenced in the photoelastic study, the central beam inside the abutment supporting the retentive ball allows for sufficient compensatory movement in order to minimize peri-implant bone loading, which is in contrast to current attachment systems employing different female inserts made from plastic materials.
