Case Report

Central Venous Perforation Despite Non-Kinking of Guide Wire and Clinically Uneventful Catheter Placement

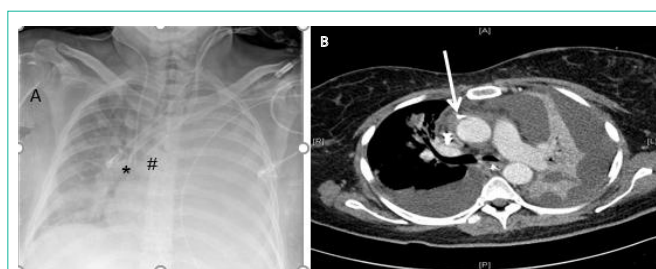
Figure 1: (A) (left) Chest X-ray (anterior-posterior) showing the left-sided 3-lumen catheter (*) and the 11F-hemodialysis catheter (#) in place. L= left (B) (right) Computed tomography after i.v. injection of contrast medium showing extra-vascular position of the hemodialysis catheter's tip as indicated by the arrow.

A 30-year old female (BMI 26.6 kg m⁻²) was transferred to our ICU requiring vasopressor support and renal replacement therapy. Due to clinical circumstances, a 3-lumen central venous catheter (CVC) and a double-lumen hemodialysis catheter (11F, length 20 cm) were placed. Under real-time ultrasound-guidance, the left internal jugular vein (LIJV) was punctured uneventfully twice. Ultrasound confirmed both guide wires within the LIJV. After advancement of the catheters to their final position blood could be aspirated over all lumen. Intravascular ECG was used for placement of the 3-lumen catheter, which was fixed on the skin level at 21 cm. Chest X-ray showed old and new catheters in place, however, a new homogenous loss of transparency of the left hemi-thorax was found (Figure 1A). Since injection of 0.9% saline into the hemodialysis catheter prior to renal replacement therapy caused retrosternal pain, computed tomography (CT) was performed immediately. The dialysis catheter was found with its tip in an extra luminal position in the anterior mediastinum. Fluid was seen close to the catheter tip (Figure 1B). A lesion of the aorta and a pericardial effusion were excluded. The massive left-sided pleural effusion required a chest tube which drained serous fluid. The hemodialysis catheter was removed uneventfully.

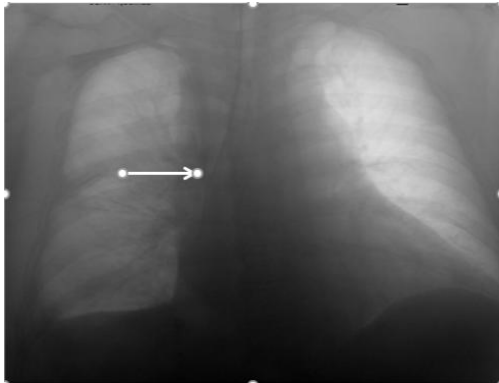
Figure 2: Chest X-ray (anterior-posterior) under CPR showing multi-lumen central venous catheter and hemodialysis catheter with projection to the superior vena cava (arrow).

CPR. A chest X-ray taken 15 min after begin of CPR showed both catheters in projection of the superior vena cava (SVC) (Figure 2) and a new opacity of the right hemi-thorax. Pericardial tamponade was excluded by transthoracic echocardiography (sub-xiphoid approach). Arguing that the subclavian catheters might be misplaced, venous access was sought *via* the femoral vessels under ultrasound guidance and finally was successful. A right-sided chest tube was inserted urgently, which drained sanguineous fluid. However, after 1.5 hours of unsuccessful CPR all efforts were suspended and the patient was declared dead. Public prosecution service was informed, however, unfortunately no forensic autopsy was ordered.
