# Direct Restoration of Posterior Teeth Using Stamp Technique and Bulk-Fill Composite Resin

**Mabrouk R\*, Oueslati A and Frih N**

Department of Dental Medicine of Charles Nicolle Hospital of Tunis, University of Monastir, Tunisia

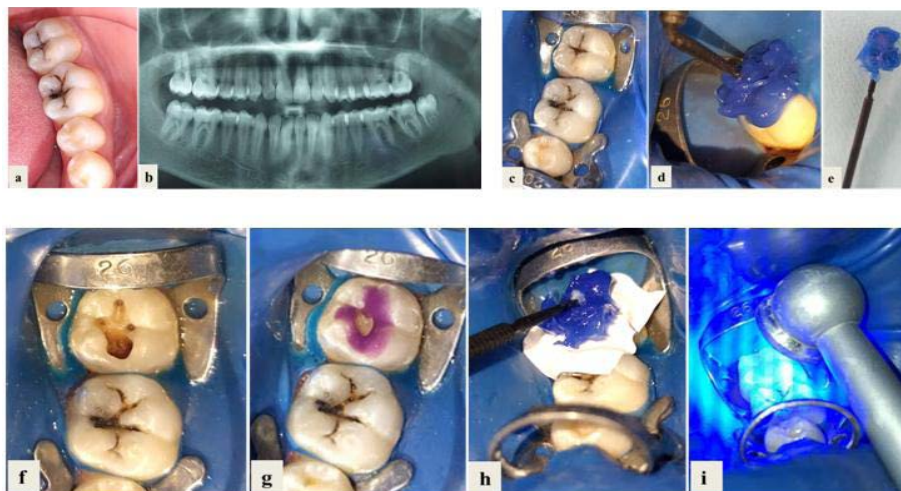
on site 1 within the occlusal table of mandibular first left molar #36. However, the second mandibular left molar #37 presented a carious lesion in the occlusal pits and grooves showing minimal occlusal structure changes. Test sensibility showed a reversible mild sensibility of cold for both teeth. The panoramic radiograph revealed a carious lesion extending to the medium inner of the dentin in the #37. As the occlusal site was seemingly intact surface overlaying an extensive lesion, the carious lesion on tooth #37 was referred to a "hidden caries" (Figure 1 a&b).

**Figure 1:** The stamp technique for site 1 on tooth #37. (a): Intraoral preoperative view; (b): Panoramic view showing the extension of the hidden caries on the second left mandibular molar tooth #37; (c): Rubber dam isolation; (d): Flowable composite resin with a microbrush; (e): The composite stamp; (f): Cavity preparation; (g): Etching; (h): The cavity was filled with bulk fill composite to level 1 mm below the occlusal surface followed by the placement of Teflon tape and the occlusal stamp; (i): Light curing after removing the stamp and Teflon tape.

The diagnosis of reversible pulp inflammation was retained for both teeth #36 and #37. Taking into account that the occlusal surface of the involved teeth had no change in their morphologies, we opted for the occlusal stamp technique for resin composite restoration of both teeth. First of all, teeth were cleaned with a silk brush and a prophylactic paste. Then, shade selection was performed using a VITA shade guide. After local anesthesia, the dam rubber dam was placed keeping the operating field dry and free of contaminants. A fine coat of Vaseline, a separating agent, was applied on the occlusal surface of the teeth to detach easily the impression material. The composite resin Ultradent™ LC Block-Out Resin material was applied to the occlusal surface, an applicator was immersed into it without touching the dental surface and the micro-brush was maintained over it with a gentle digital pressure than light-cured to fabricate the occlusal stamp. It was light cured and thus occlusal stamp was fabricated. After its complete curing, the stamp was removed and the corresponding edge on the buccal surface of the tooth was marked for orientation at the time of the stamp repositioning (Figure 1c,d&e).

Carious tissues were removed throughout the occlusal access of the #37 and a site 1 cavity adhesive preparation was prepared. After the complete removal of the carious lesion, the cavity was rinsed with chlorhexidine solution 0.2% and the dentin-pulp complex was lined with calcium hydroxide phosphate cement liner (Biner LC, Meta Biomed').

Selective Enamel etching was done using 37% phosphoric acid (Meta Etchant, Meta Biomed) for 30 seconds followed by dentin for 15s. The cavity was abundantly rinsed, then dried carefully with chip blower to obtain white frosted appearance in enamel. However, the surface of the dentin was kept slightly moistened the must be left moist “wet bonding”, in order to avoid collagen collapse by absorbing excessive water using a cotton pellet. The cavity margins were then coated with a bonding agent (Ambar universal bonding FGM) and light-cured for 20 seconds with an LED source. The cavity was restored using a bulk nano-hybrid composite resin (Opus Bulk Fill APS, FGM) up to 1 mm lower of the occlusal surface then light cured for 20s. The final increment layer of composite resin was added and before light curing, a piece of Teflon film was applied on the occlusal surface. The

occlusal stamp, previously done, was firmly placed over the Teflon tape to achieve the morphological configuration corresponding to the initial situation of the occlusal surface. Next, the tape was removed and the occlusal excess of composite resin was eliminated then light cured for 40s using LED source (Figure 1 f,g,h&i).

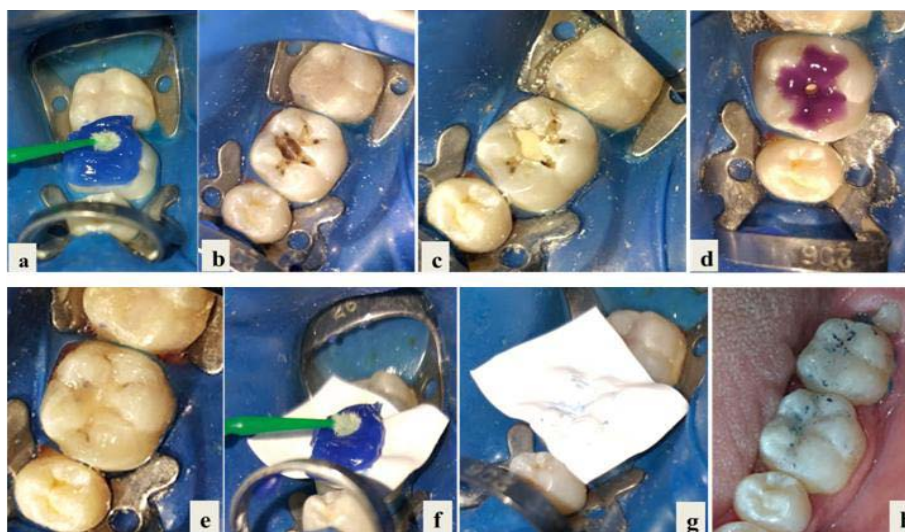
**Figure 2:** The stamp technique for site 1 cavity of the tooth #36. (a): The stamp; (b): caries removal; (c): calcium hydroxide lining; (d): phosphoric acid etching; (e): the cavity was filled with bulk fill composite resin; (f): the placement of Teflon tape and the occlusal stamp; (g): view directly after removing the stamp; (h): postoperative intra oral view.

Assuming the second left mandibular molar #37, the first left mandibular molar #36 was launched. The tooth was restored in the same manner (Figure 2 a,b,c,d,e,f&g).

The surfaces were polished using fine-grained abrasive flexible discs (SofLex Discs, 3M ESPE) and silicone polishing points. Finally, the rubber dam was removed and occlusion relations were checked and it was found that there was no need for adjustment. The

immediate result duplicates the original surface anatomy (Figure 2h).
