## Case Report

# Aesthetic Restoration of Maxillary Incisors with Composites: Case Report

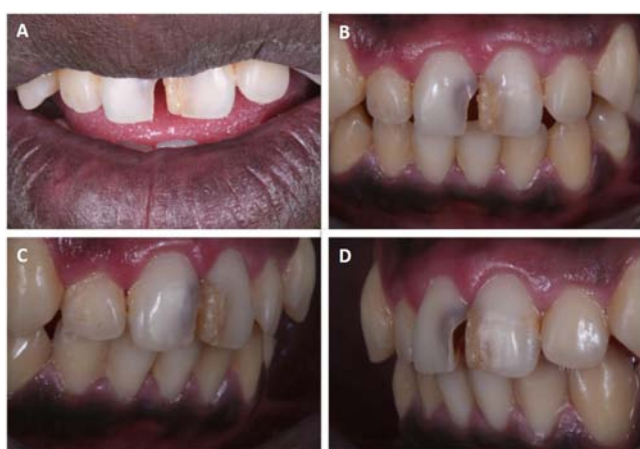
In the clinical examination, facial aspects, smile, gingival architecture and dental characteristics were analyzed. In the right maxillary incisor, extensive carious lesion was observed with involvement of the mesial side and the all three thirds of the dental element, featuring a class IV cavity. The left maxillary incisor presented an extensive composite resin restoration showing rough aspect and color change (Figure 1). Radiographically, there was a radiolucent area on the proximal surfaces (Figure 2).

**Figure 1:** Initial aspect of the patient's smile. Caries lesion in the right maxillary incisor and poor composite restoration in left maxillary incisor. A – Smile. B- Intra-oral frontal view. C- Right side view. D- left side view.

The clinical planning suggested direct composite restorations for both maxillary central incisors.

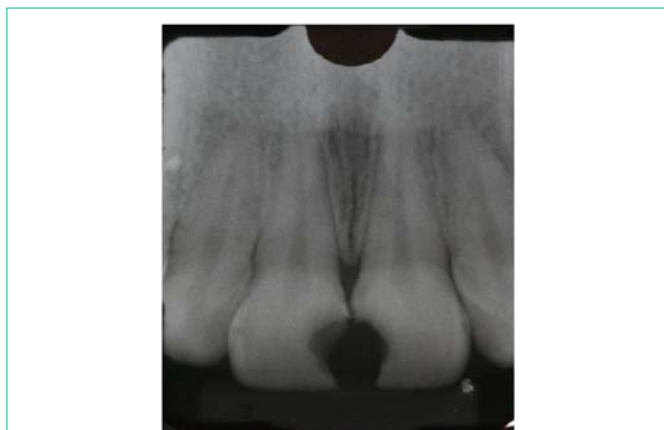
**Figure 2:** Radiographic aspect of radiolucent areas.

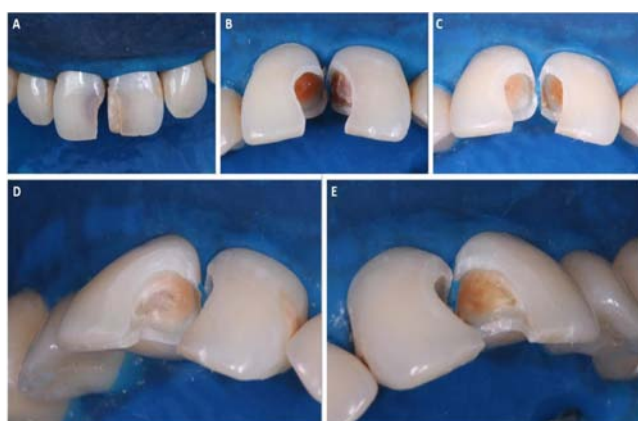
**Figure 3:** Rubber dam isolation. A- Frontal view. B- Caries exposure. C- End of teeth preparation. D- Teeth prepared in a left side view. E- Teeth prepared in a right side view.

Rubber dam isolation was performed then the restoration was removed with a diamond bur No. 1014 (KG Sorensen, Brazil) 21 and the infected dentin exposed. The infected dentin was removed with carbide bur # 6 (KG Sorensen, Brazil) at low speed (Kavo, Joinville, Santa Catarina, Brazil). A bevel on the buccal surface was made with a tapered bur No. 2200 (KG Sorensen, Brazil) (Figure 3).

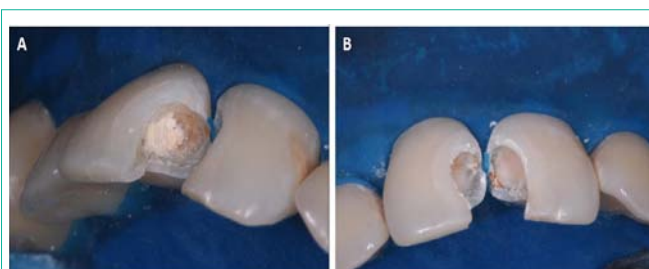
**Figure 4:** Pulp-Dentin complex protection. A- Calcium-Hydroxide cement. B- Glass ionomer cement.

Due to a thin remaining dentin, calcium hydroxide cement based (Hydro C, Dentsply, Brazil) was inserted in the pulpal wall of each element as a protective agent for the pulp-dentin complex. Glass ionomer cement (R Maxxion; FGM, Joinville, SC, Brazil) was applied over the calcium hydroxide cement, acting as cavity base (Figure 4).

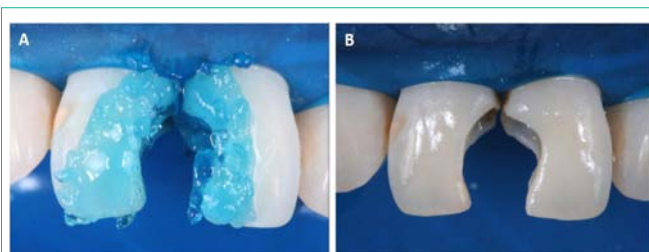
**Figure 5:** A- 37% acid etching B- Adhesive system.

The surfaces were treated according to the total-etch technique, 37% phosphoric acid (Condac 37; FGM, Joinville, SC, Brasil) for 30 s (enamel) and 15 s (dentine), rinsed for 20s, dried by air spray and excess water was removed with absorbent paper. The adhesive (Ambar, FGM, Joinville, SC, Brazil) was applied with disposable tips (Cavibrush; FGM, Joinville, SC, Brazil), followed by air spray to evaporate the solvent and 10 s photo activation (Radii plus – SDI – Australia -1,500mW/cm<sup>2</sup>) (Figure 5).

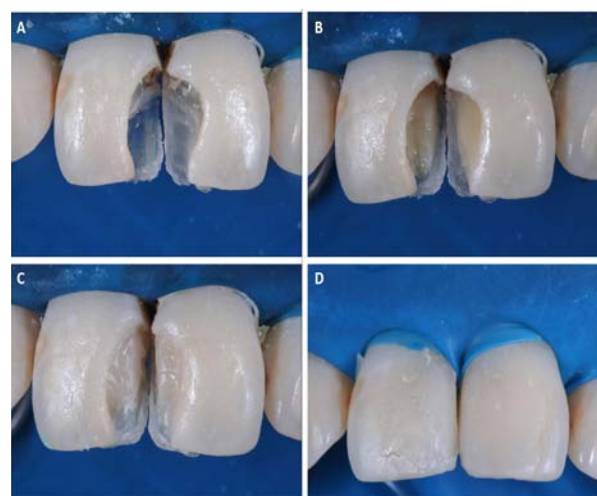
**Figure 6:** A- Restoring palatal enamel with an enamel composite shade AT. B- Restoring dentin with a shade A3D composite. C- Using a body composite shade A2B. D- Restoring buccal enamel with a shade A2E composite.

Increments of enamel shade composite AT, (Filtek Z350 XT, 3M / ESPE, St. Paul, MN, USA) were placed for rebuild the lingual enamel, first in the right incisor, and photo activated by time of 20 seconds. The same protocol was followed in the left incisor. Layers of dentin shade composite, A3D (Filtek Z350 XT, 3M / ESPE, St. Paul, MN, USA) and body shade A2B (Filtek Z350 XT, 3M / ESPE, St. Paul, MN, USA) were applied and light cured for 20 seconds. Resin effect shade BT (XT Filtek Z350, 3M / ESPE, St. Paul, MN, USA), were placed between the incisal edge and dentinal mammelons in order to reproduce translucency and opalescence of this region. An enamel shade composite A2E (XT Filtek Z350, 3M / ESPE, St. Paul, MN, USA) was placed as the last increment (Figure 6). Glycerin based gel

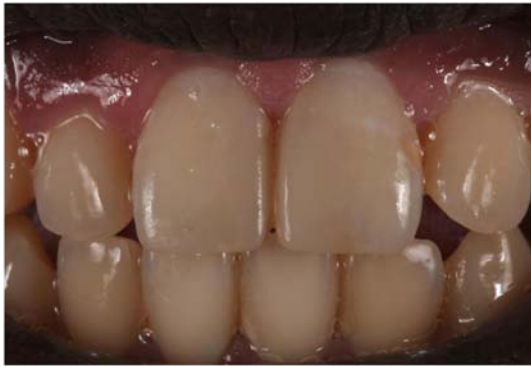
**Figure 7:** Final restoration after finishing and polishing.

The rubber dam was removed, and the oclusal adjustment performed with fine and extra-fine flame-shaped diamond burs, 3168 F and 3168 FF (KG Sorensen, Brazil). Restoration's finishing and polishing were performed for dental contouring regularization; sanding discs Sof-Lex Pop-On (3M ESPE, USA) were employed followed by multilaminate burs on the buccal surface for smoothing resin. Abrasive silicone based rubbers were used for surface smoothness. Buccal characterizations (primary and secondary anatomy) were prepared with a diamond bur at high speed no 3195 (Kavo, Joinville, Santa Catarina, Brazil) (Figure 7).
