Case Report

Salvage of an Existing Construct With Stacked Plating

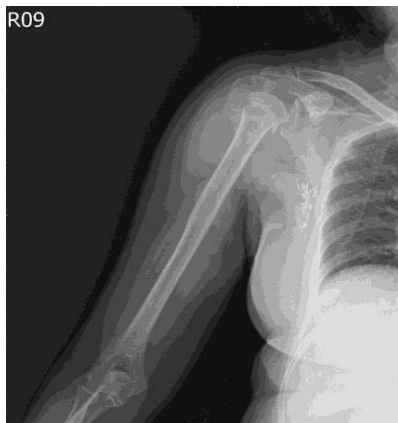
Figure 1: Radiograph of the right upper arm showing a four-part proximal humerus fracture. Note the surgical clips in the axillary region that remain from her previous breast surgery.

Patient is an 82-year-old woman who fell while strolling through the park. She entered the emergency department (ER) complaining of extreme pain on her right upper arm. Physical examination revealed abundant ecchymosis around the arm and chest, tenderness upon palpation, and limited Range of Shoulder Motion (ROM). No neurovascular abnormalities were noted. Initial radiograph of the right upper arm revealed a proximal humerus fracture with severe comminution of the humeral head (Figure 1). Considering the age of the patient, the severity of the fracture, and the osteoporotic quality of her bone, a hemiarthroplasty would be the treatment of choice. However, after informing the patient of the benefits and risks of such procedure, she decided that restoring shoulder motion, function and strength as close to her pre-injury levels as possible would suit her active lifestyle better. Therefore, Open Reduction and Internal Fixation (ORIF) were performed. During surgery, with the help of both allogenic and artificial bone grafts, the fracture was reduced and fixated with a proximal humerus internal locking system (PHILOS) plate (Synthes, Switzerland). Postoperatively, the radiograph showed

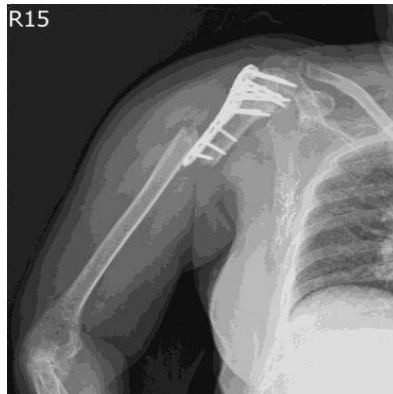
Figure 3: Radiograph of the right upper arm showing a peri-implant humeral shaft fracture at the junction of the proximal and middle third. Note the loosening of the most distal screw but retention of the overall prosthesis from the initial surgery.

Unfortunately, about seven weeks after the surgery, patient fell again and landed on the injured arm. She complained of similar right upper arm pain and was brought to ER for help, where swelling and bruising of the upper arm were also noted. Precautionary radiograph showed a humeral shaft fracture at the junction of the proximal and middle third just around the most distal screw from the previous surgery (Figure 3). At this point, a second surgical procedure would be necessary not only to allow continuous bone healing of the previous fracture but also to reduce and fixate the new peri-implant humeral shaft fracture. After searching through literature and carefully weighing the advantages and disadvantages of various options such as hemiarthroplasty, Reverse Total Shoulder Arthroplasty (RTSA), and Intramedullary (IM) nailing, a salvage procedure of the existing construct with stacked plating was decided.

Over the previous operation scar, a vertical incision was made and extended further distally to expose the new fracture site. Since the initial ORIF occurred only seven weeks ago, removing the prosthesis would certainly cause a collapse of the ongoing healing fracture, not to mention a waste of the bone grafts. In addition, because the proximal portion of the prosthesis appeared radiographically stable, a decision was made not to remove the previous construct. After removing four screws from the proximal portion and three screws from the distal portion, an exact but longer (twice the length) PHILOS plate was stacked on top of the existing prosthesis after proper reduction was performed. By using and stacking identical plates of different lengths, it was assured that the screw holes would also be stacked on top of each other and that the same locking screws can be used to fixate and lock both plates to the bone firmly. Overall, a total of six screws were exchanged and locked through the overlapping portion of the stacked plates while six screws were locked distally through the non-overlapping portion of the longer plate for secure fixation. Even though the secondary procedure had extended the exposure to the middle third of the humeral shaft, care was taken during placement

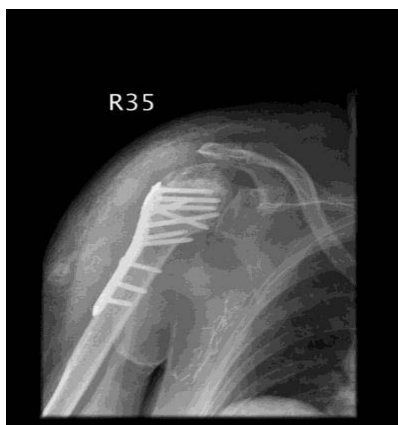
Figure 2: Postoperative radiograph showing fixation with a locking proximal humeral plate and bone grafts in the treatment of the aforementioned fracture.

good alignment and the arm was immobilized with a shoulder sling (Figure 2).

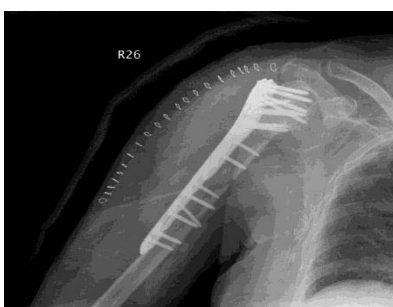
Figure 4: Postoperative radiograph after the salvage procedure showing good reduction and fixation with the stacked plates and screws.

Postoperatively, the arm was immobilized in a sugar tong splint due to the osteoporotic quality of the bone and because the same bone had suffered two fractures in less than two months (Figure 4). At one month post-op, the splint was removed as gentle mobilization of the right upper arm and shoulder began without resistance. Neither skin necrosis nor wound dehiscence was observed. During the latest follow up at three-months (almost five months after the initial surgery), the patient was asymptomatic, did not complain of reduced shoulder strength, and had good functional recovery with the following ROM: 115 degrees of flexion, 30 degrees of extension, 110 degrees of abduction, 40 degrees of external rotation, and 45 degrees of internal rotation. She was able to perform daily activities without pain or limitations and did not report any discomfort from the bulkiness of the prostheses (Figure 5).
