Clinical Image

A Case Study of Radial Nerve Injury after Segmental Humeral Fracture, Followed by Primary Intramedullary Nailing

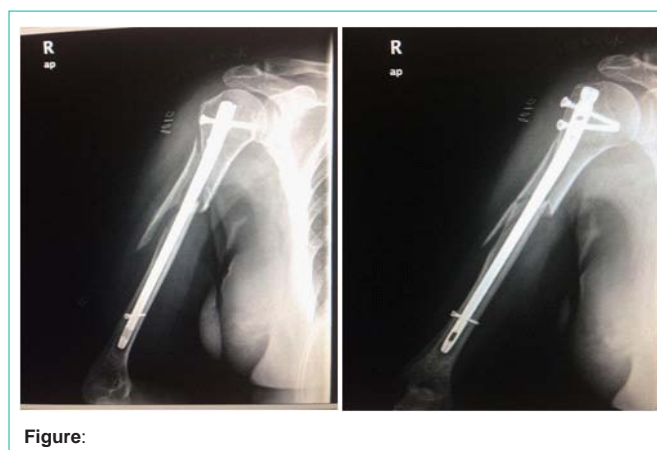
Figure:

We present the radiological images of a case study of a 78 years old female patient, who sustained a 2 parts segmental humeral fracture, followed by primary intramedullary nailing. Post operatively (9th day post-operation), electro diagnostic studies determined an axonal type of radial nerve injury, included motor nerve conduction study to the extensor indicisproprius, sensory nerve conduction study of the superficial branch of the radial nerve, and needle EMG of radial-innervated muscles and non-radial muscles supplied by the C7 nerve root.
