Aortic Root Dilatation and Loss of the Aortomitral Curtain due to Paravalvular Leakage after Double Valve Replacement: A Case Report

A man who had undergone double valve replacement surgery was admitted with paravalvular leakage. Aortic root dilated and only a small amount of tissue was found around the aortomitral curtain. These anatomical changes were thought to be the result of longstanding PVL. We performed bent all operation with aortomitral reconstruction and mitral valve replacement. The patient was managed successfully and we report it.

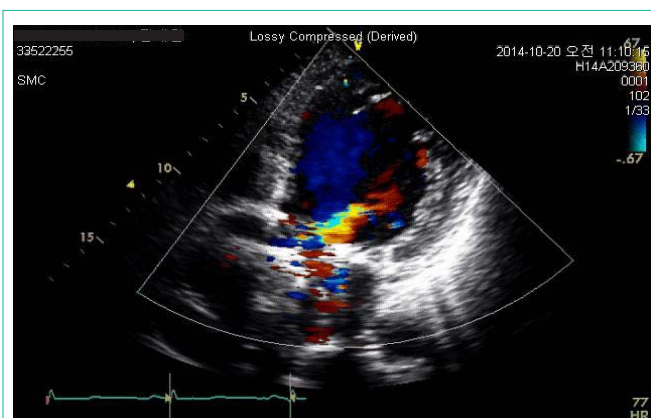
Figure 1: Preoperative transthoracic echocardiogram. A preoperative Transthoracic Echocardiogram (TTE) showed moderate-to-severe aortic regurgitation from paravalvular leakage.

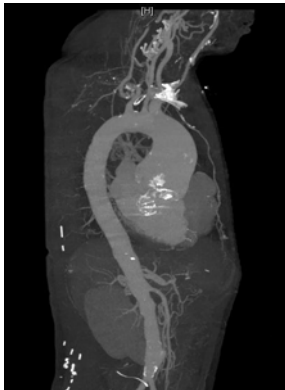
Figure 2: Preoperative CT angiography. CT angiography revealed a 60mm ascending thoracic aortic aneurysm and 66mm dilated aortic root.

A 50-year-old man was admitted to a local medical center with symptoms of progressive dyspnea for three weeks. About 24 years previously he underwent Double Valve Replacement (DVR) surgery for infective endocarditis of the aortic and mitral valves. A transthoracic echocardiogram revealed severe aortic regurgitation with a dilated aortic root and moderate left ventricular dysfunction. The patient was transferred to our hospital for further evaluation and management, and additional echocardiography and thoracic computed tomographic angiography were performed. The Transthoracic Echocardiogram (TTE) showed moderate-to-severe aortic regurgitation due to paravalvular leakage, a well-functioning prosthetic mitral valve and mild-to-moderate tricuspid regurgitation (Figure 1). CT angiography revealed a 60-mm ascending thoracic aortic aneurysm and 66mm dilated aortic root (Figure 2).

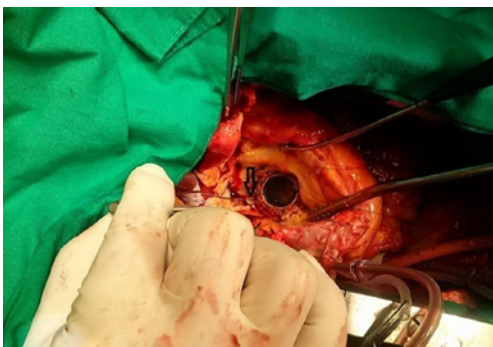
Figure 3: Intraoperative findings. A 1mm probe was inserted into the left ventricle through the hole between the sewing ring and aortic annulus (black arrow).
