Special Article: Plastic Surgery

The Role of 3D Scanning in Evaluating Burn Progression

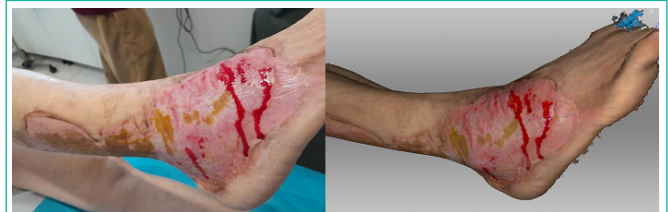
On the 11th day after the injury, photographs and scans of the affected area were taken (Figure 1). The photograph shows a burn on the dorsum of the right foot, deeper second-grade burns centrally, with third-grade burns extending to the back of the shin. On the periphery of the wound, gradual epithelialization is visible, while the center of the wound shows necrotic brownish tissue with a pale surrounding base. The 3D scan of the area clearly distinguishes the zone of epithelialization and the areas containing necrotic tissue.

Figure 1: Photograph (left) and 3D scan (right) of the burn on the 11th day after its occurrence.

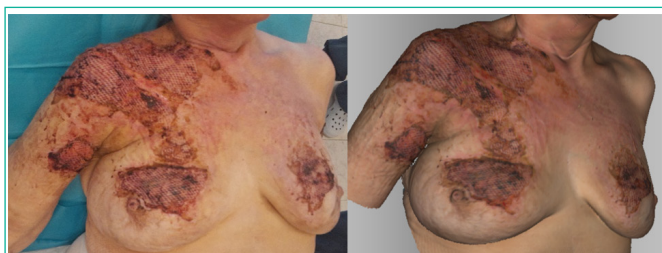
Figure 9: Photograph (left) and 3D scan (right) of the burn on the 22nd day after its occurrence, after the application of meshed dermoepidermal skin grafts.

In the photograph taken on the 22nd day post-injury, the patient is after surgery, during which dermoepidermal meshed skin grafts were transplanted to the right arm, chest, and both breasts (Figure 9). The grafts in the photograph appear vital, while the surrounding area on healthy skin is contaminated due to dried blood clots. The skin shows vital dermoepidermal grafts with a well-defined texture from the meshing, which correspond in extent and vitality to the photograph. Additionally, the skin contamination due to dried blood clots, which match the color seen in the photograph, is also visible.
