## Special Article: Plastic Surgery

## The Role of 3D Scanning in Evaluating Burn Progression

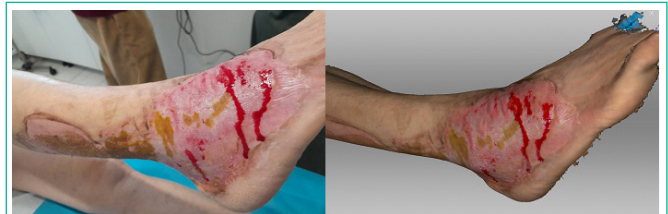
**Figure 1:** Photograph (left) and 3D scan (right) of the burn on the 11th day after its occurrence.

On the 11th day after the injury, photographs and scans of the affected area were taken (Figure 1). The photograph shows a burn on the dorsum of the right foot, deeper second-grade burns centrally, with third-grade burns extending to the back of the shin. On the periphery of the wound, gradual epithelialization is visible, while the center of the wound shows necrotic brownish tissue with a pale surrounding base. The 3D scan of the area clearly distinguishes the zone of epithelialization and the areas containing necrotic tissue.

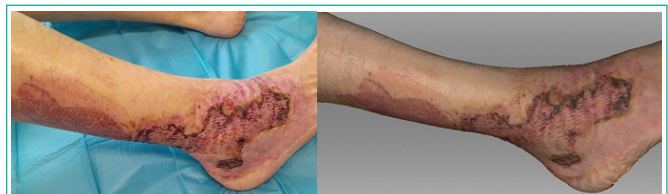
**Figure 3:** Photograph (left) and 3D scan (right) of the burn on the 26th day after its occurrence, following the application of meshed dermoepidermal skin grafts.

On the 26th day after the injury, the photograph shows a nearly completely healed dermoepidermal graft, with scabs present at its edges (Figure 3). A clearly defined area of the wound, which healed spontaneously, is visible next to the graft on the dorsum of the foot. On the back of the shin, a completely healed wound is visible. The scan shows the healed dermoepidermal graft in the same extent as seen in the photograph. The boundary of the graft, where scabs are present, is clearly defined, and beyond it, the peripheral area of the wound that healed spontaneously is visible. The back of the shin corresponds to the healed area.

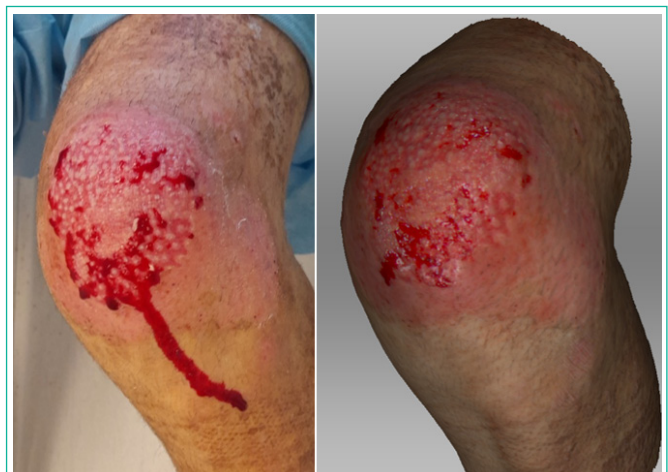
**Figure 4:** Photograph (left) and 3D scan (right) of the burn on the 9th day after its occurrence.

In the photograph taken on the 9th day after the injury, a superficial burn on the left knee is visible, affecting only the partial thickness of the dermis (Fig. 4). The wound shows red areas of tissue with a vital base and pale pink tissue between them, forming epithelial islands. On the 3D scan, this contrast between the unhealed wound and the epithelial islands is even more pronounced. Additionally, on the lateral side of the knee, a spontaneously reepithelialized portion of the wound is clearly visible, both in the photograph and on the scan.

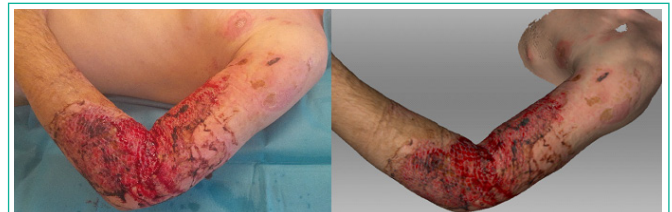
**Figure 6:** Photograph (left) and 3D scan (right) of the burn on the 10th day after its occurrence, after the application of meshed dermoepidermal skin grafts.

A 48-year-old man was admitted to the hospital for a burn on his left upper extremity, from the shoulder to the wrist, after being scalded with hot water. He was initially hospitalized at a local hospital and then transferred to a specialized burn center on the 10th day after the injury for burn therapy. The burn covered 6% of his body (3% superficial and 3% moderate to deep). Areas requiring surgical treatment were identified, and a necrosectomy and dermoepidermal grafting were performed. The postoperative course was uncomplicated, and the areas gradually healed completely. On the 10th day after the injury, the photograph clearly shows the area after necrosectomy and subsequent meshed skin grafts in the left shoulder and forearm, following a previous deep full-thickness burn (Figure 6). On the lateral side of the shoulder and the proximal third of the forearm, small areas of necrotic tissue and scabs are visible in addition to the grafts. The scan clearly shows the meshed dermoepidermal graft, with the necrotic tissue in brown color, distinguishable from the scabs, which appear slightly darker than in the photograph.

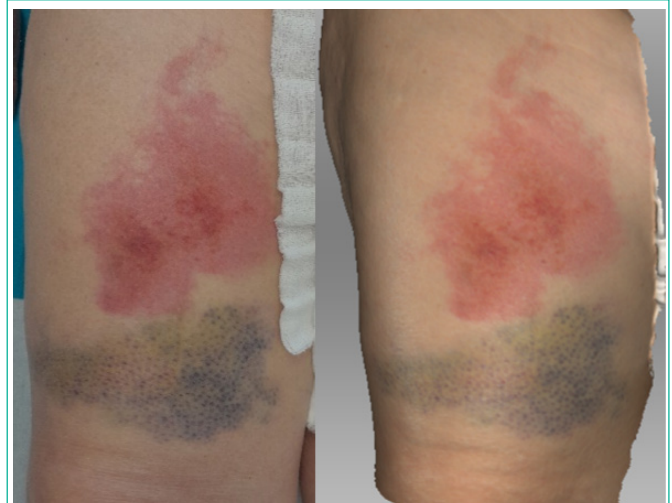
**Figure 7:** Photograph (left) and 3D scan (right) of the burn on the 4th day after its occurrence.

In the photograph taken on the 4th day after the injury, a superficial burn is visible on the ventral surface of the right thigh, with a subcutaneous hematoma located distally (Figure 7). The scan clearly defines the contours of the burned area, both in terms of extent and depth, providing sufficient detail for objective assessment. The scan also shows a well-defined hematoma, with color and extent corresponding to the injury.

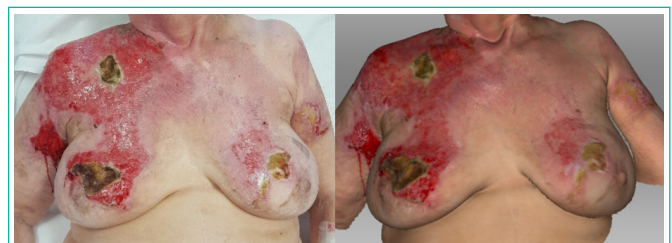
**Figure 8:** Photograph (left) and 3D scan (right) of the burn on the 15th day after its occurrence.

On the 15th day post-injury, the photograph shows burns in the area of the right shoulder, upper arm, chest, and breast, which affect almost the full thickness of the skin and have a shiny appearance due to the formation of necrotic coverings (Figure 8). On the trunk to the right and on both breasts, there are clearly defined dry necroses of brown color. To the right of the trunk, peripheral to the deep burns, there is distinct pale pink tissue corresponding to the spontaneously healed portion of the wound. On the skin, there is a clearly defined brown necrosis with a whitish border observed on the right side of the chest and subsequently better defined developing necrotic coverings. The vitality of the wound base corresponds to the photograph. However, on the skin, the boundary between the already healed wound and the open wound is better defined. On the breast to the right in the upper medial quadrant extending into adjacent quadrants, there is a well-defined dry necrosis, with a surrounding area presenting a wound with a vital base, where the developing necrotic coverings are clearly visible in the corresponding extent as seen in the photograph.

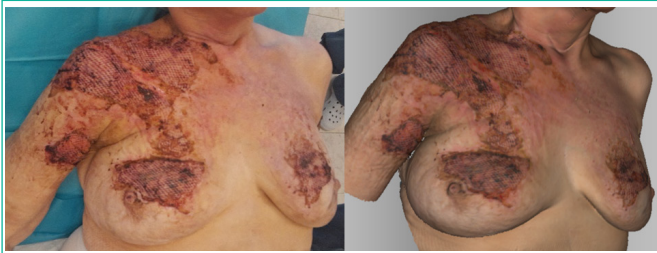
**Figure 9:** Photograph (left) and 3D scan (right) of the burn on the 22nd day after its occurrence, after the application of meshed dermoepidermal skin grafts.

In the photograph taken on the 22nd day post-injury, the patient is after surgery, during which dermoepidermal meshed skin grafts were transplanted to the right arm, chest, and both breasts (Figure 9). The grafts in the photograph appear vital, while the surrounding area on healthy skin is contaminated due to dried blood clots. The skin shows vital dermoepidermal grafts with a well-defined texture from the meshing, which correspond in extent and vitality to the photograph. Additionally, the skin contamination due to dried blood clots, which match the color seen in the photograph, is also visible.
