Austin Journal of Gastroenterology

Clinical Image

Hematochezia in a Liver Transplant Recipient with Incisional Hernia Repair

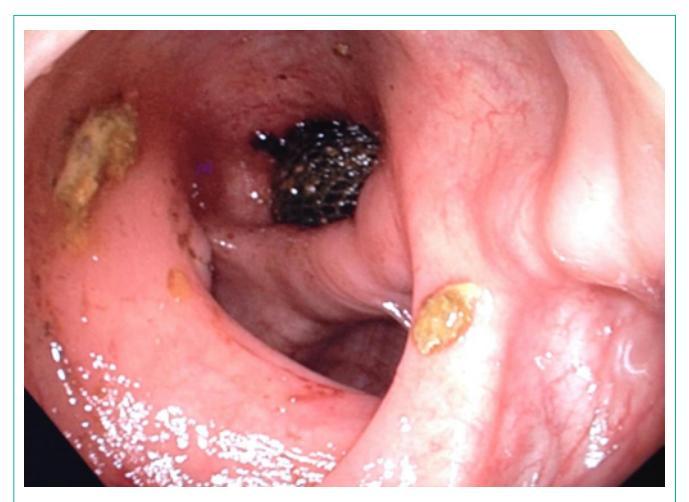
Figure 1: Photo taken during colonoscopy. Location is transverse colon in liver transplant recipient with remote mesh hernia repair.

The correct answer is e. Mesh erosion into colon. The patient had a remote liver transplant complicated by a large incisional hernia. The hernia was repaired with polypropylene mesh placed in the preperitoneal position which eroded into the transverse colon several years after the repair (Figure 1).
