Research Article

The Influence of Magnetic Resonance on the Microstructure and Shear Bond Strength of Silver Palladium Dental Alloy and Feldspathic Porcelain

Sakrana AA^{1*}, El-Bediwi AB², Al-Ragaei D² and Özcan M³

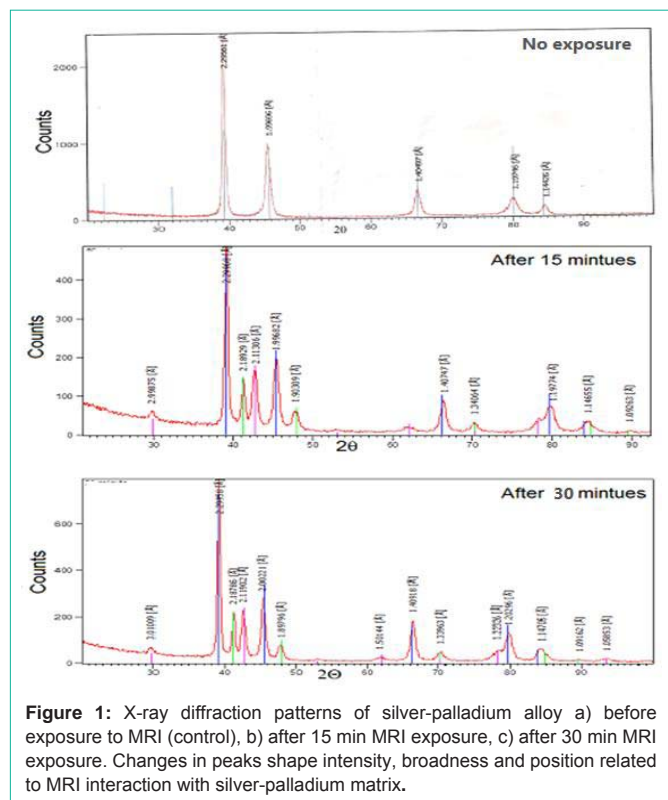
Figure 1: X-ray diffraction patterns of silver-palladium alloy a) before exposure to MRI (control), b) after 15 min MRI exposure, c) after 30 min MRI exposure. Changes in peaks shape intensity, broadness and position related to MRI interaction with silver-palladium matrix.

Figure 1a-1c shows XRD patterns of silver-palladium dental alloy before and after exposure to MRI for 15 and 30 minutes. The details of formed phases such as; intensity, position and Miller indices of silver-palladium alloy are shown in (Table 2). From X-ray analysis, it is obvious that the silver-palladium alloy consists of Ag-Pd face centered cubic phase. Also formed peaks of silver-palladium alloy representing; the shape intensity, broadness, position and number changed after exposure to MRI. This means that the interaction of MRI with silver-palladium matrix alloy caused changes due to its thermal and magnetic effects.

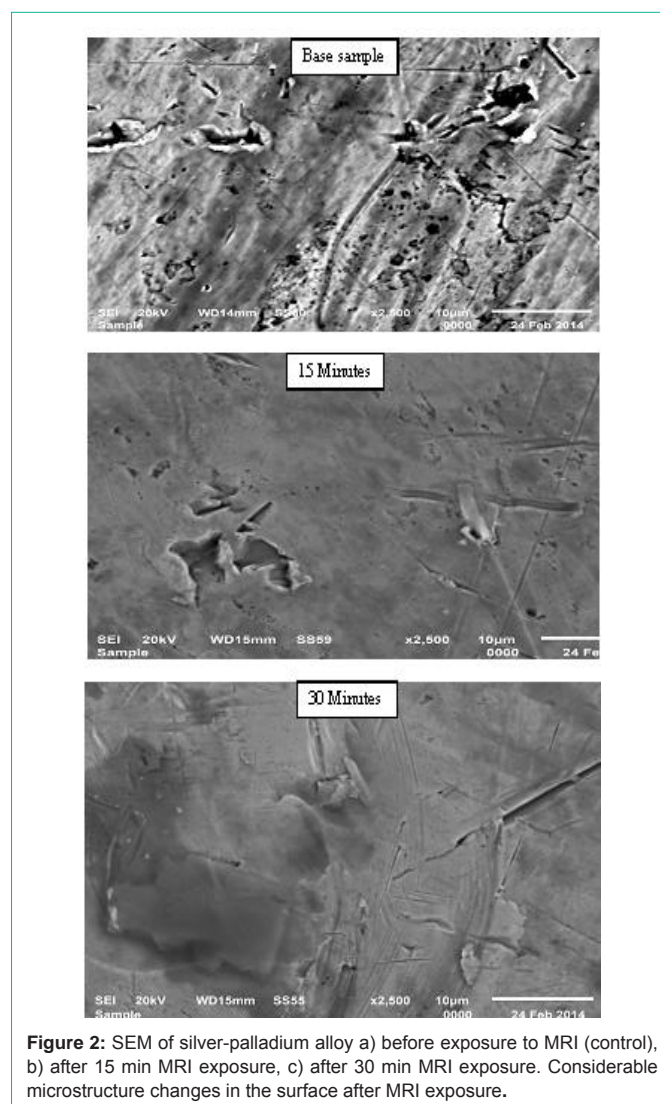
Figure 2: SEM of silver-palladium alloy a) before exposure to MRI (control), b) after 15 min MRI exposure, c) after 30 min MRI exposure. Considerable microstructure changes in the surface after MRI exposure.

Scanning electron micrographs of silver-palladium alloy as a control and after exposure to 1.5 T MRI for 15 and 30 minutes are shown in Figure 2a-2c. SEM analysis of silver-palladium alloy showed a considerable change of the microstructure after exposure to MRI (Figure 2a), lamellar structure with fine grain and different rod shape was detected. Figure 2b-2c showed a change in lamellar structure and large grains with different orientations and formed different slabs). These results were also proved by the X-ray diffraction analysis. Fine dispersions were observed at control group (M1) and it was changed to coarse grains after MRI exposure time at 15 and 30 minutes in groups (M2 and M3).

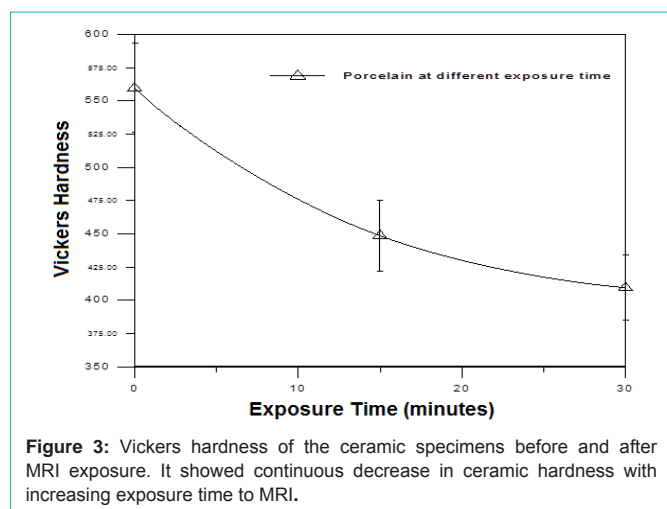
Figure 3: Vickers hardness of the ceramic specimens before and after MRI exposure. It showed continuous decrease in ceramic hardness with increasing exposure time to MRI.

Figure 3 and (Table 4) showed that the Vickers's hardness of feldspathic ceramic was decreased with increasing the MRI exposure time compared to control specimens. There was significant decrease

in hardness after exposure to MRI from 562.20 ± 1.25 to 409.4 ± 0.43 .
