Clinical Image

Hematochezia in a Liver Transplant Recipient with Incisional Hernia Repair

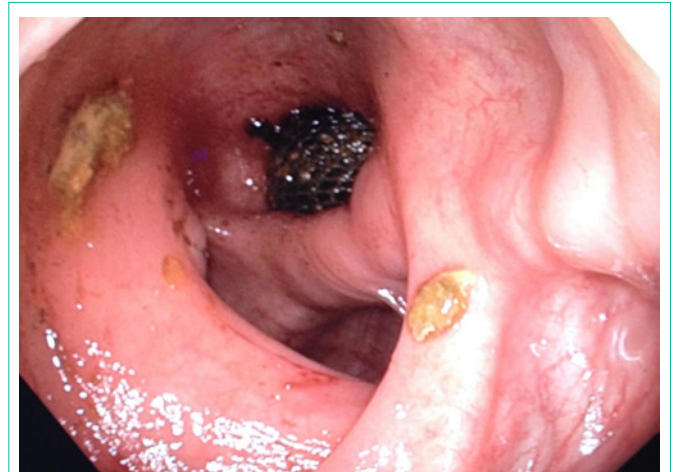
The correct answer is e. Mesh erosion into colon. The patient had a remote liver transplant complicated by a large incisional hernia. The hernia was repaired with polypropylene mesh placed in the pre-peritoneal position which eroded into the transverse colon several years after the repair (Figure 1).

Figure 1: Photo taken during colonoscopy. Location is transverse colon in liver transplant recipient with remote mesh hernia repair.

The correct answer is a. Intra-peritoneal placement of polypropylene mesh. Intra-peritoneal placement of polypropylene mesh is associated with late erosion into visceral structures and has been well described. If intra-peritoneal placement cannot be avoided, absorbable or biologic mesh is preferred although would be expected to have higher recurrence rates. Optimal placement is in the pre-peritoneal space or in the retro-rectus space. Mesh overlay is an option but has higher infection and recurrence rates.

This question does not necessarily have a “correct” answer as care must be individualized depending on patient condition and site of erosion. Answer c. Laparoscopic Repair with mesh excision and primary colon repair is unlikely to be achievable due to expectation of dense, extensive adhesions and in addition would be expected to have a higher complication rate from primary colon repair. Optimally, segmental excision of the affected colon segment with primary repair would be desired and given the contaminated field biologic or bio-absorbable mesh would be the best choice for abdominal wall reconstruction. Choice d. might be necessary in worst case scenarios if a large mesh repair was previously done and involving a large portion of the colon with dense adhesions. In our case, the patient had decompensated cirrhosis several years out from his transplant and he was felt to have excessive expected mortality from operative repair. Therefore observation alone was chosen. He had small periodic bleeding episodes occurring once or twice a month before he died due to complications of his cirrhosis several months later.
